Fracture Critical Bridge Inspection Report

NBI Bridge No.: 00972

Route N3610 over LITTLE DEEP FORK CREEK
Creek County

3/11/2013

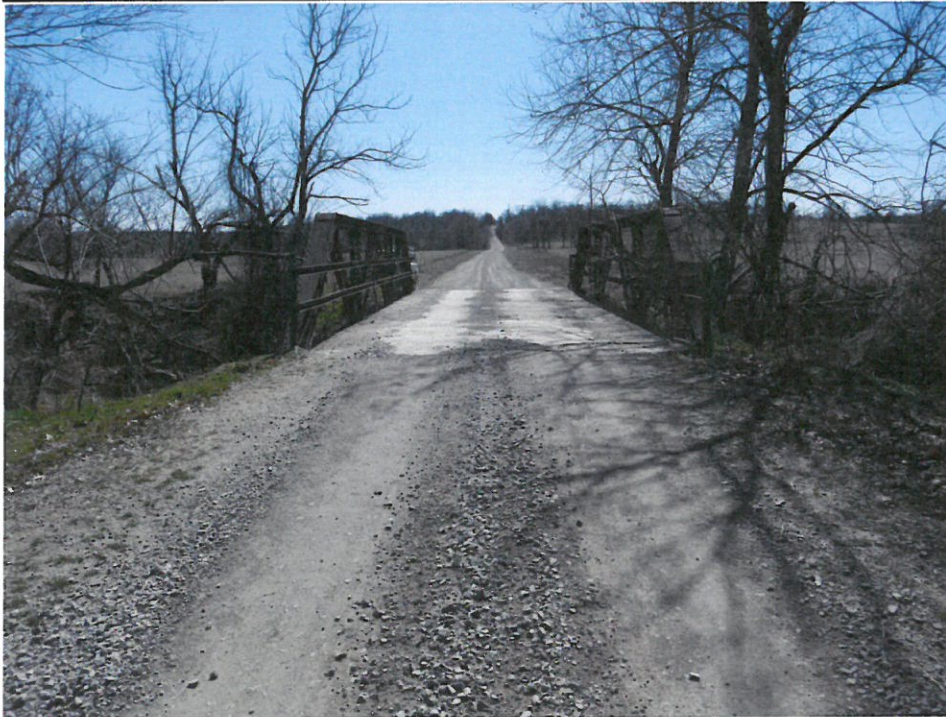
- **PX** – Bridge end markers are missing from all four corners of the bridge (**photo 1**).
- The bridge rail is bent due to vehicular collision at the southeast corner of the bridge.
- None of the traffic safety items meet current standards for a non-National Highway System roadway.

Photograph 1 - End view looking south. Note: Missing bridge end markers.

- Install bridge end markers at all four corners of the bridge.
- Seal cracks in the deck to prevent deck drainage from infiltrating the deck and causing damage to the concrete and floor system members.
- Periodically remove soil and debris from the deck, lower chord, truss bearings and abutment seats to inhibit corrosion of the adjacent structural steel members.
- Abrasively clean and paint the ends of the truss members and gusset plates at the bearings where active corrosion exists due to the panel points being buried under soil. Monitor the corrosion holes in the gusset plates at the northwest bearing for signs of distress and additional section loss.
- Remove hanging lower lateral bracing rod. Consider replacing missing lower lateral bracing should the deck need to be replaced.
- Remove tree at west edge of bridge.

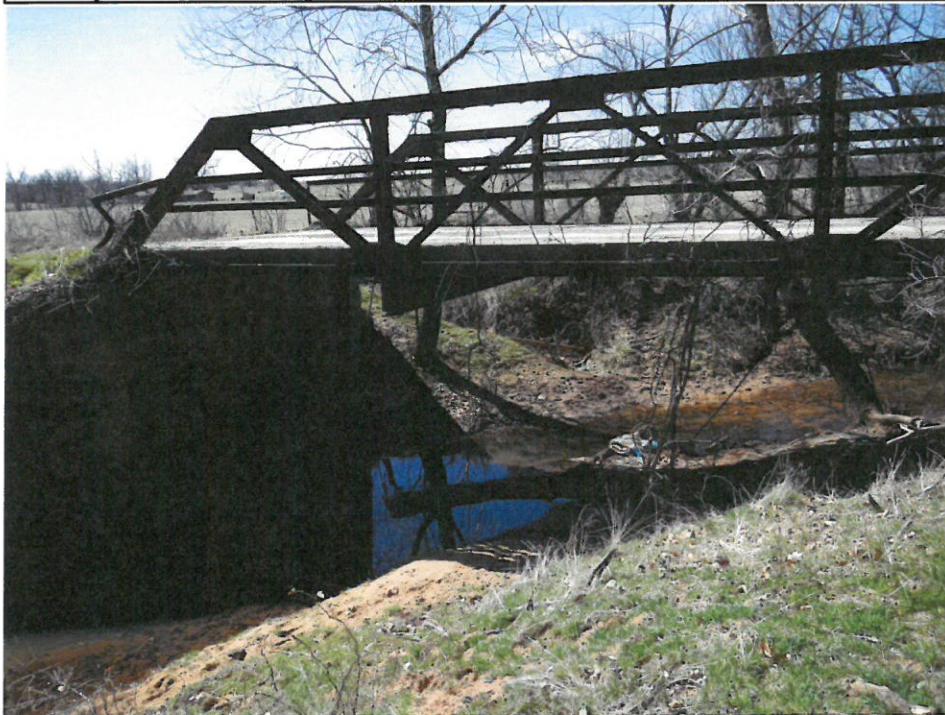
Photograph 2 - Elevation looking west.

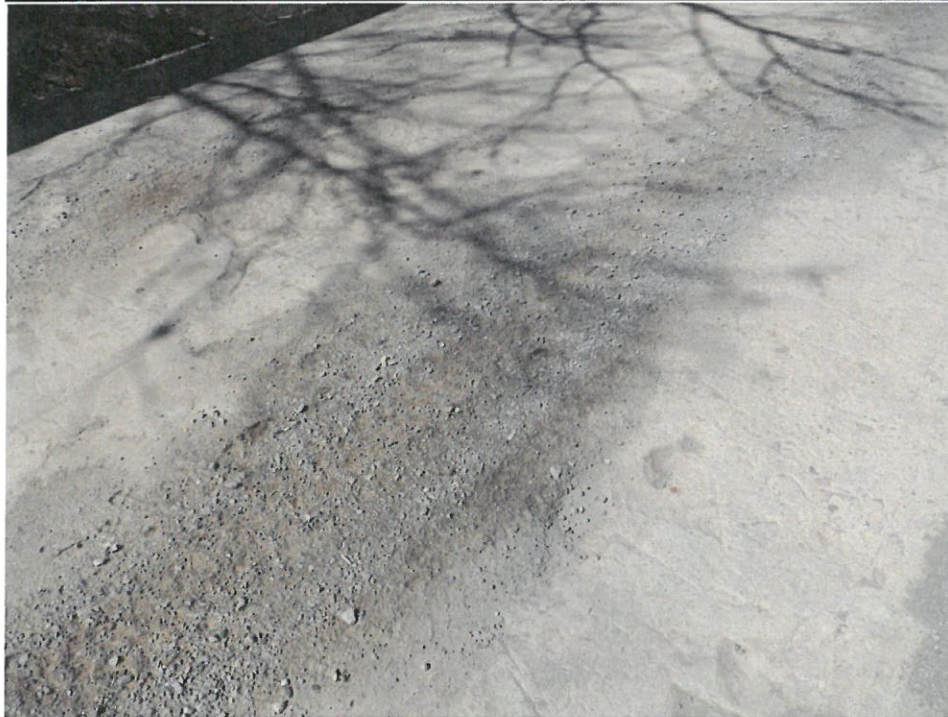
- **PX** – The concrete deck surface has numerous indentations and transverse cracks (**photo 5**). The cracks at the wheel lines are worn to 1/8-inch wide at the surface.
- **PX** – Soil and debris have accumulated on the deck between the wheel lines (**photo 5**). The soil and debris tend to hold moisture, allowing drainage to infiltrate the deck cracks, which promotes deterioration of the deck and floor system.
- **FX** – Several small spalls (less than 1 square foot) exist in the underside of the deck between stringers 1 and 2 near floor beam 1 (**photo 6**). The spalls expose corroded longitudinal reinforcing steel. It is unusual that the longitudinal reinforcing is exposed, as the transverse reinforcing should be closest to the surface of the deck underside.

Photograph 5 - Looking northwest at typical deck condition. Note: Transverse cracks and debris.

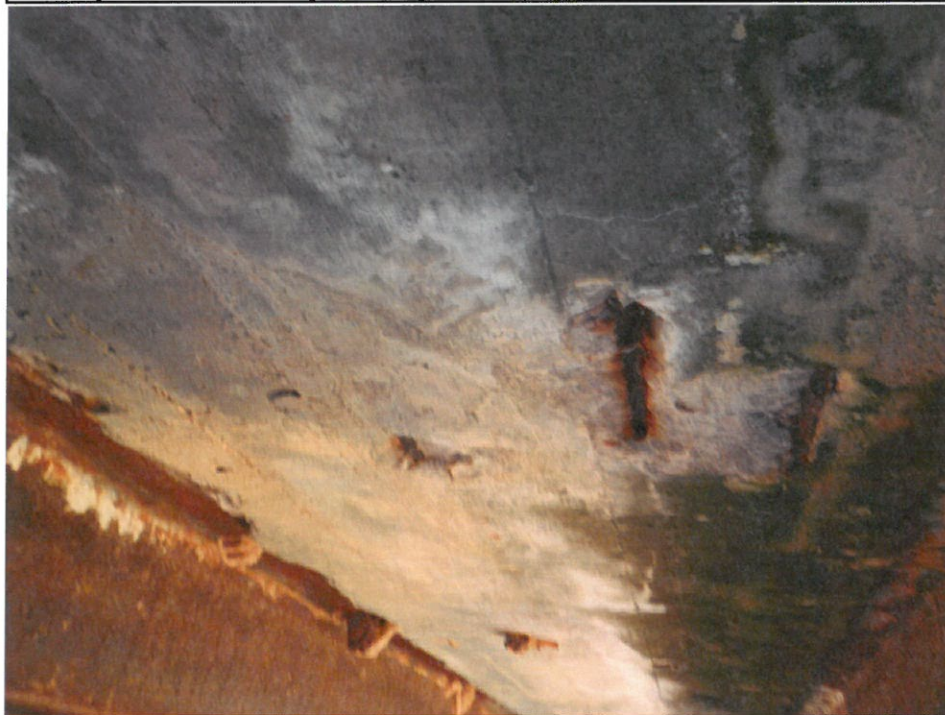
Photograph 6 - Looking north at underside of the deck between stringers 1 and 2, near floor beam 1.
Note: Spall with exposed reinforcing steel.

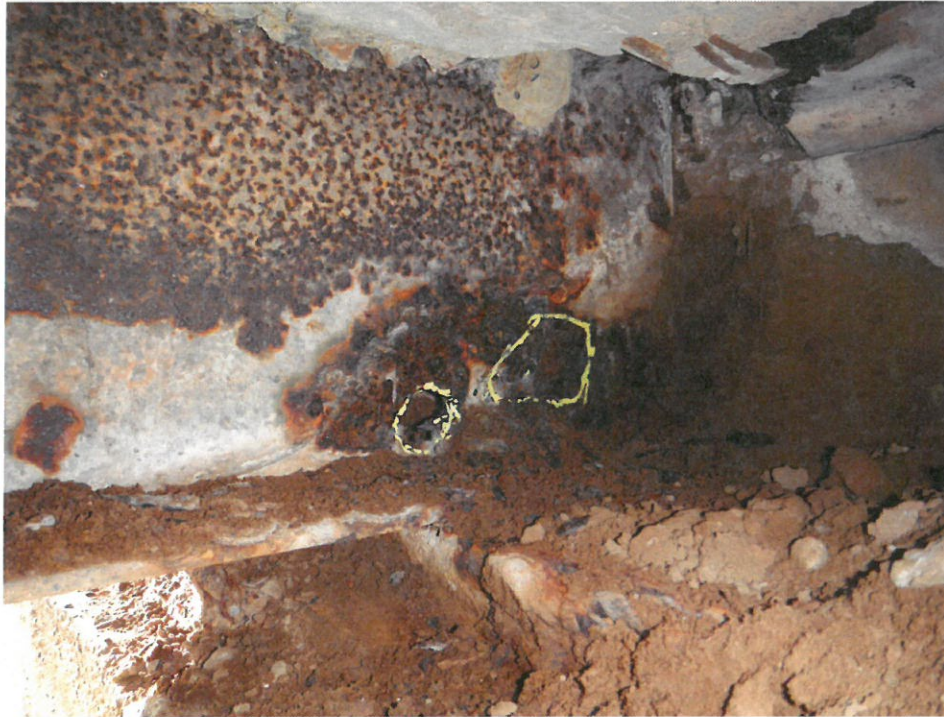
- **PX** – A 1-inch long and a 3-inch long corrosion hole exists through the web of stringer 1 at the north abutment (**photo 7**). This is due to the stringer ends being encased in soil at the bearing seat. There appears to still be adequate section in the stringer web over the bearing area to support the exterior stringer; however, corrosion and loss will continue to occur if soil remains against the steel.
- **PX** – The stringer ends are encased in soil at both abutments (**photo 8**). With the exception of stringer 1 at the north abutment, the section loss is negligible.
- The stringers are unpainted and typically have surface corrosion with no significant section loss throughout the bridge

Photograph 7 - Looking northwest at stringer 1, north abutment. Note: 1-inch and 3-inch square corrosion holes and section loss of stringer web.

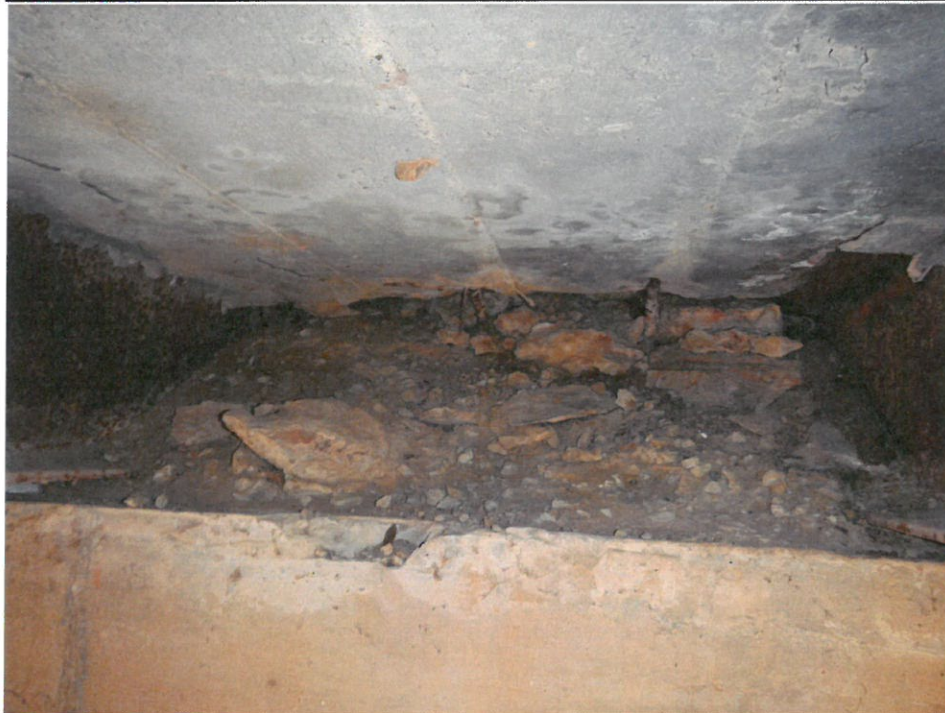
Photograph 8 - Looking south at south abutment bridge seat between stringers 2 and 3. Note: Soil and debris on bridge seat.

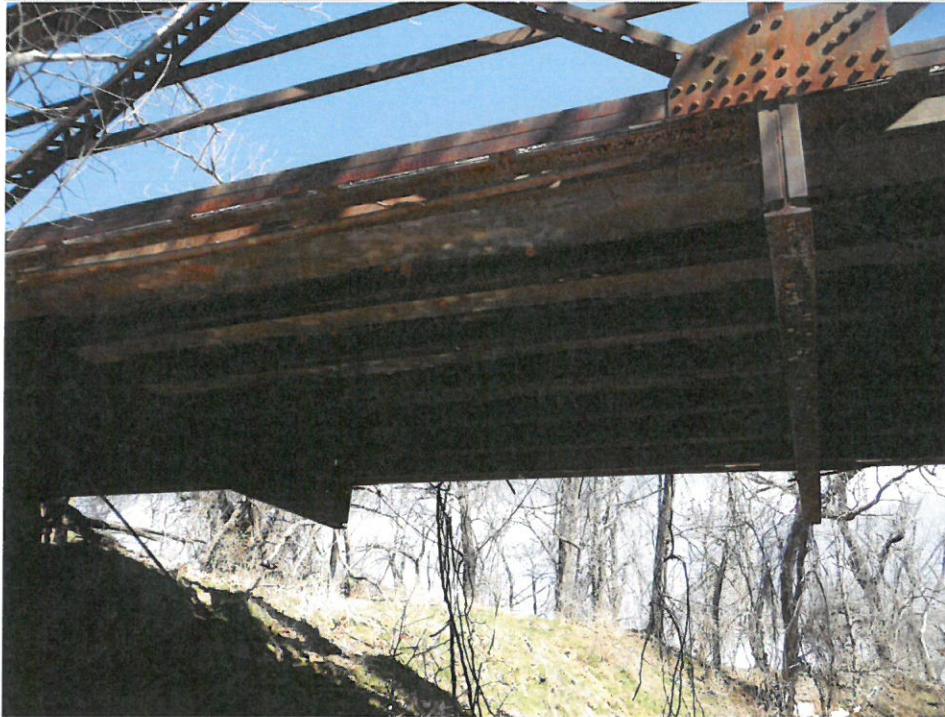
- **PX** – The lower lateral bracing is missing between floor beams 1 and 2, with the bracing rod hanging from the west end of floor beam 2 (**photo 9**). The lower lateral bracing is not crucial on this bridge since there is a concrete deck to resist lateral loads.

Photograph 9 - Looking east at floor system between floor beam 1 and 2. Note: Broken and missing lower lateral bracing rods.

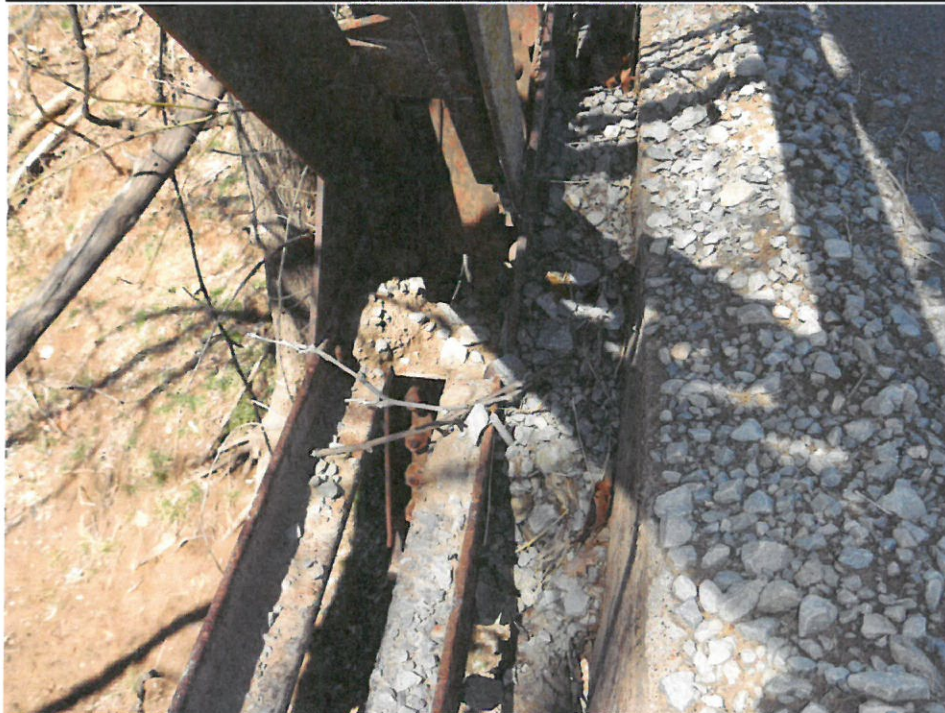
- **PX** – Gravel and debris are spilling from the deck surface onto the lower chord (**photo 10**). Surface corrosion with pitting less than 1/16-inch deep exists under the debris. This debris holds moisture and promotes corrosion of the steel.

Photograph 10 - Looking north at west L2. Note: Debris on lower chord.

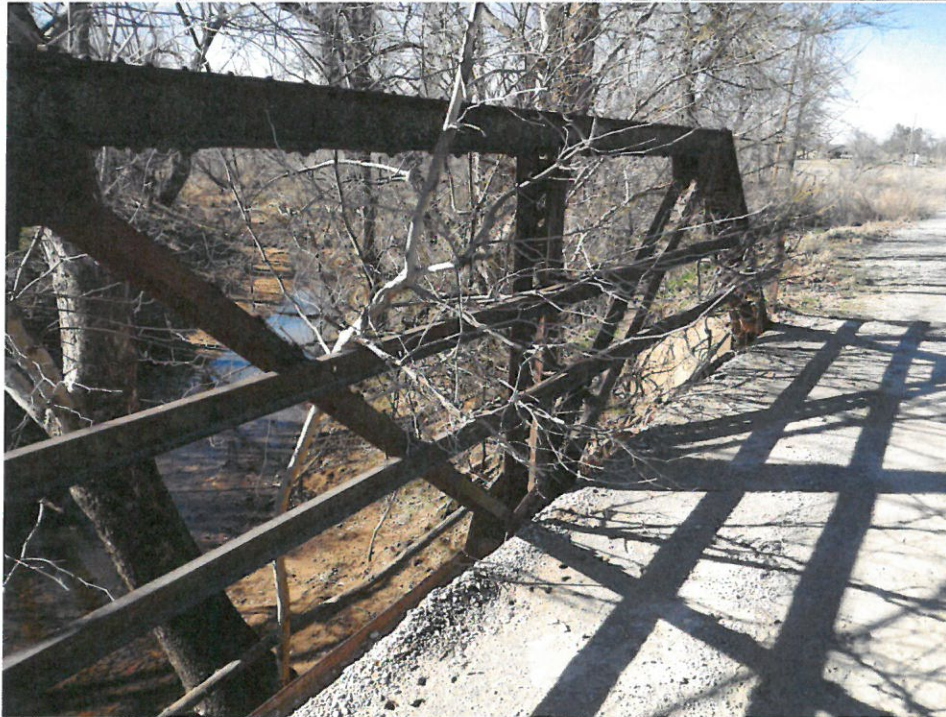
- **PX** – Tree branches are growing through both trusses (**photo 11**). Vegetation tends to shade and drop foliage, both of which prolong dampening of the steel and promote corrosion.
- **FX** – Square headed bolts were used to connect the verticals and diagonals to the gusset plates. These bolts transfer the force of the member by bearing against the holes in the connecting members and are considerably weaker connections than modern friction type bolts where the forces are transferred by clamping action.
- Truss verticals and diagonals are unpainted and typically have surface corrosion with no significant section loss.

- **PX** – A large tree exists along the west truss and is leaning over the creek just upstream of the bridge (**photo 11**). Should this tree fall across the channel, the resulting flow around the fallen tree could cause scour issues.

Photograph 11 - Looking northwest at west truss. Note: Tree near truss has branches growing through the truss.

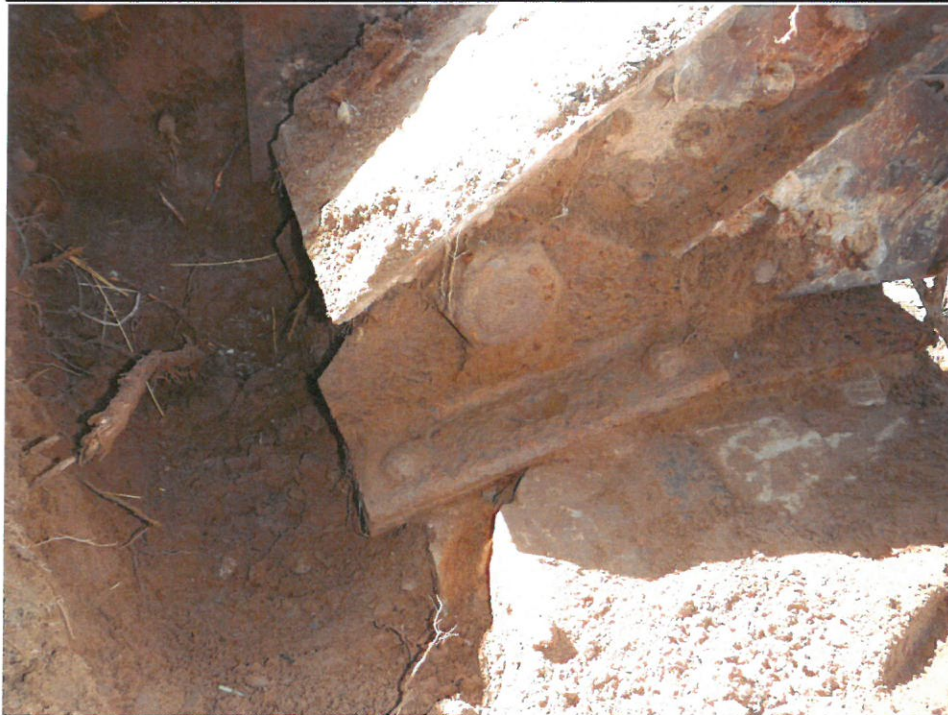
- **PX** – The end posts exhibit active corrosion with pitting up to 1/8-inch deep near the bearings due to the ends of the being engulfed in soil (**photo 12**).
- The end posts are unpainted and typically have surface corrosion with no significant section loss throughout the remainder of the member.

Photograph 12 - Looking west at east truss bearing, south abutment. Note: End post is pitted where buried; Bearing is rotated 17 degrees and has slid 9 1/2 inches to the south.

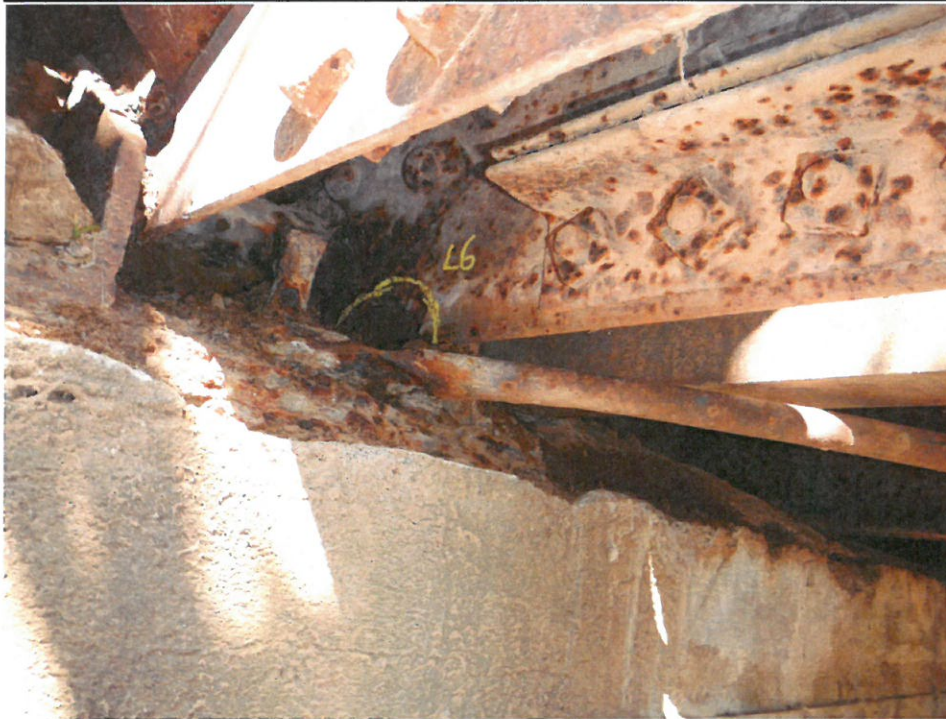
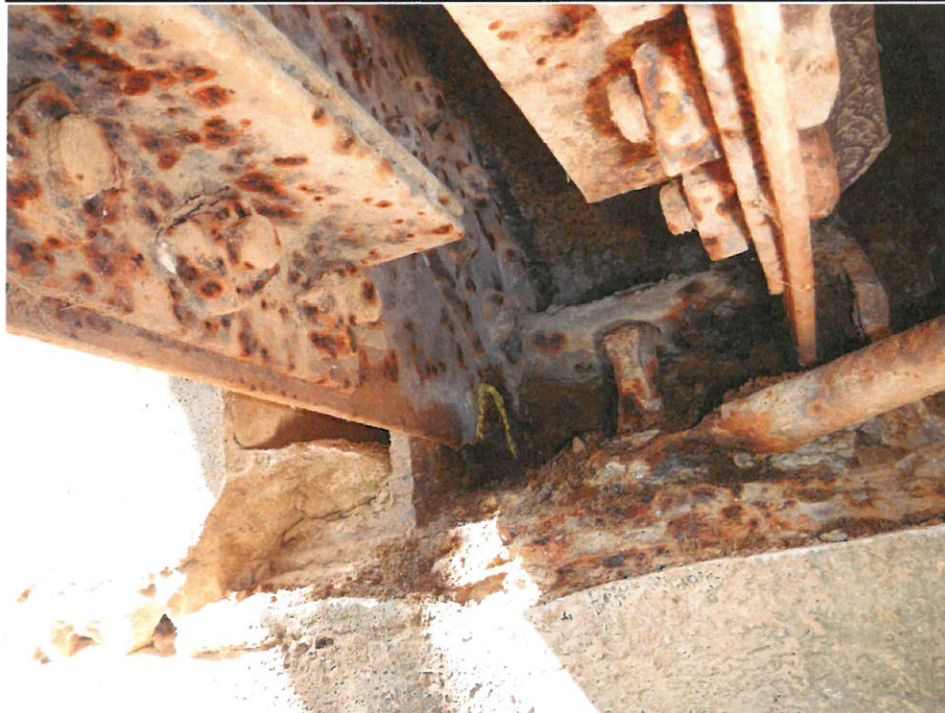
- **PX** – The gusset plates at L6 corrosion holes measuring 1 1/2-inches vertical by 3-inches horizontal in the inboard plate and 1-inch vertical by 1 1/2-inches horizontal in the outboard plate (**photos 13 and 14**). The steel surrounding the corrosion holes is knife edged for 2 inches. This corrosion and section loss is due to the end of the truss being engulfed in soil.
- **PX** – Gusset plates at the L0 and L6 typically have active corrosion with pitting up to 1/8-inch deep. The corrosion and section loss is due to the ends of the truss being engulfed in soil.

Photograph 13 - Looking northeast at west L6. Note: 1 1/2-inch x 3-inch corrosion hole with surrounding section loss at inboard gusset plate.

Photograph 14 - Looking northwest at west L6. Note: 1-inch x 1 1/2-inch corrosion hole with surrounding section loss at outboard gusset plate.

The gusset plates at the northwest bearing have corrosion holes and extensive section loss that will require analysis. If the gusset plates require repair, we will send sketches to retrofit the section loss. These gusset plates should be cleaned and painted to prevent additional section loss.

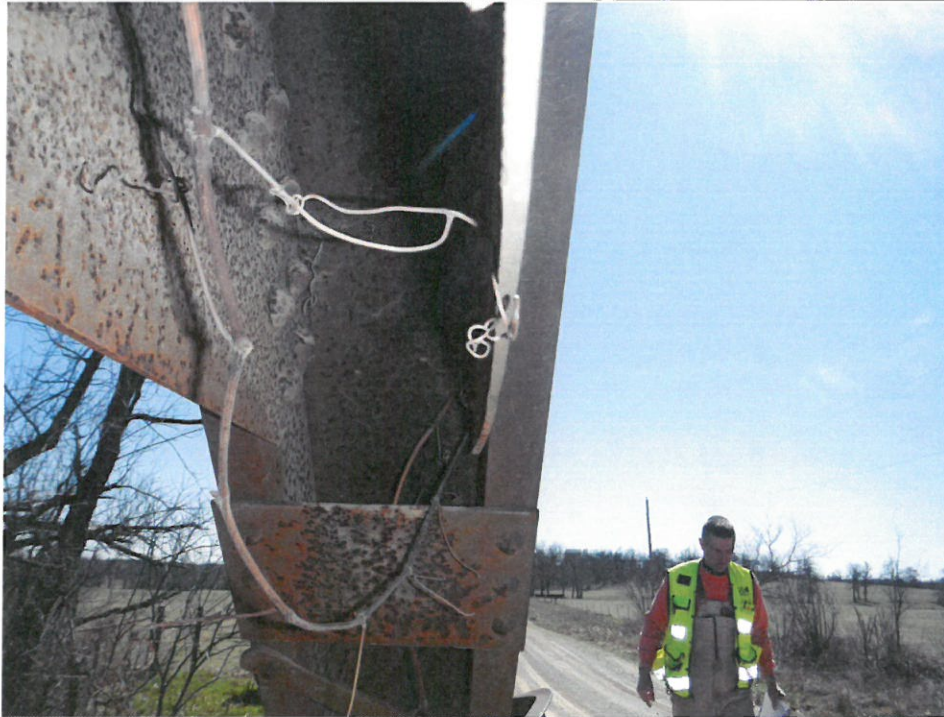
Photograph 15 - Looking south at east U1. Note: Inboard gusset plate bowed 1/8-inch.

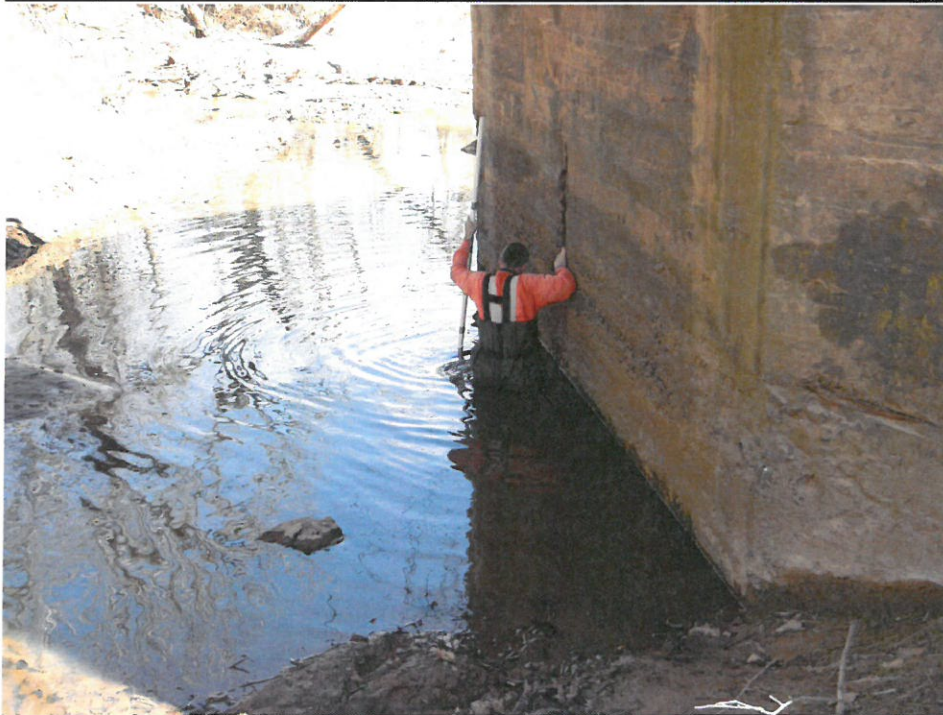
- **CX** – A 3 foot deep scour hole exists along the breastwall of the south abutment, exposing the top of the footing. The stream is currently directed towards the south abutment at an approximate angle of 30 degrees.

Photograph 16 - Looking east along south abutment. Note: Scour has occurred along the abutment.

- A 3.5-foot deep scour hole exists at the face of the south abutment. We recommend riprap be placed along the face of the abutment and for 40 feet upstream of the bridge to protect the substructure from further scour.

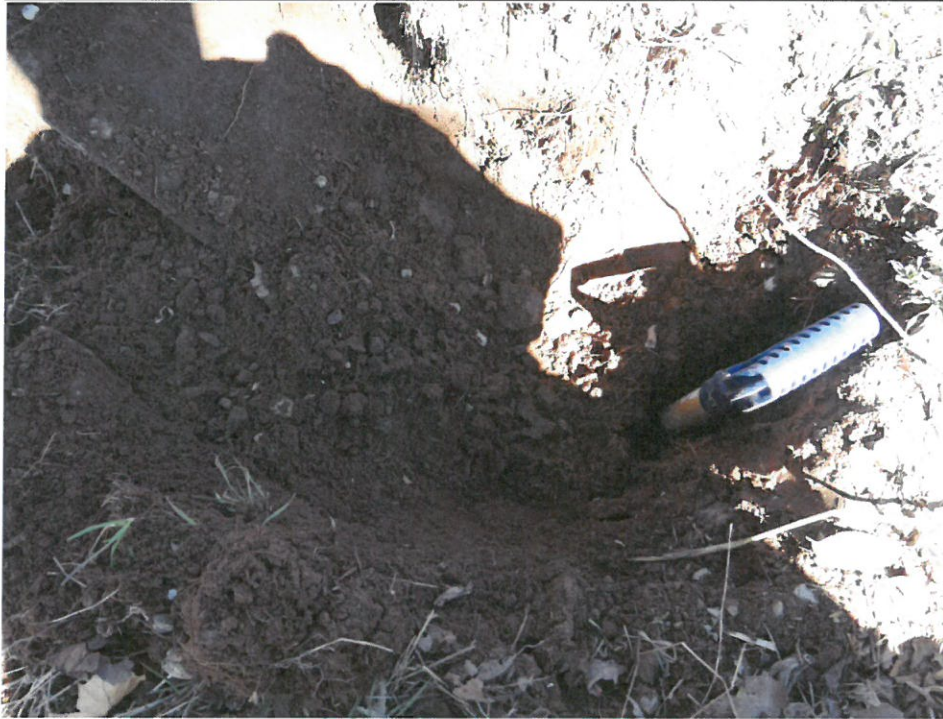
Photograph 17 - Looking northeast at west truss bearing, south abutment. Note: Soil is loose behind abutment wall as evidenced by shovel easily pushed down to handle.

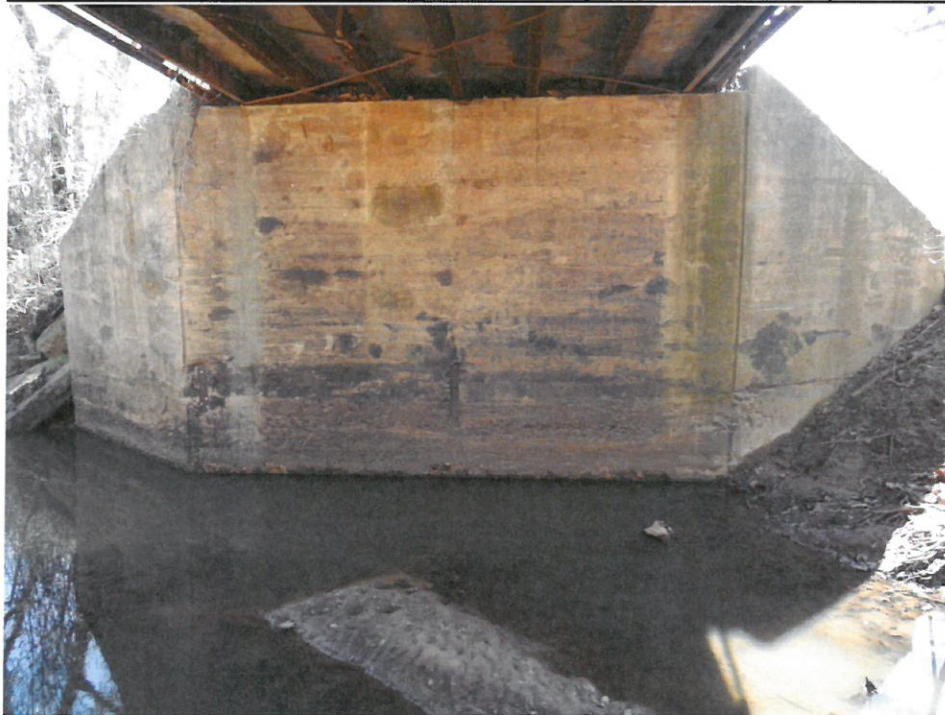
- Shallow spalls exposing embedded steel members were observed in the face of the south abutment near the bridge centerline and under the east bearing seat (**photo 18**). The exposed steel occurs approximately 6 feet above the bottom of the channel.

Photograph 18 - Looking south at south abutment. Note: Spalls with exposed embedded steel members.

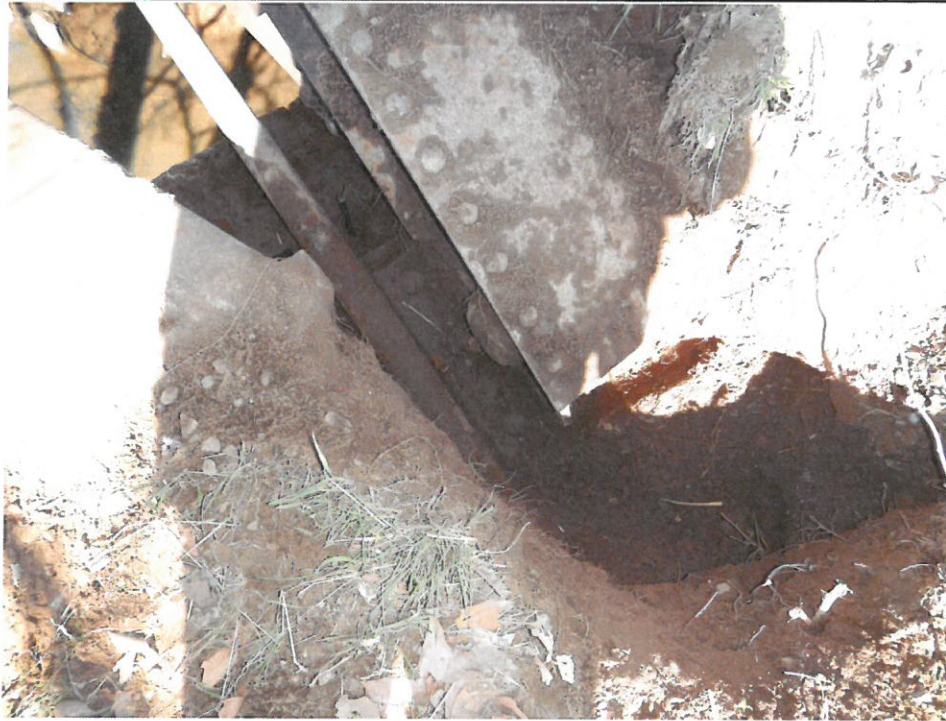
Photograph 19 - Looking northeast at west truss bearing, south abutment. Note: Bearing is rotated 21 degrees and has slid 9 inches to the south.

- The bearings at the south abutment have partially fallen off of the abutment back wall and the masonry plates are now rocked 22 degrees on the west truss and 17 degrees on the east truss. Repair options were discussed with David Howard at the bridge site on March 13. One option is to place piles along the south edge of the south abutment backwall to allow the bearings to be jacked. The piles should be driven to the top of the abutment footing (or to refusal if the piles miss the foundation) and should be attached to the backwall. Once the bearings are level, the jacks can be encased in concrete to act as the permanent bridge seat.

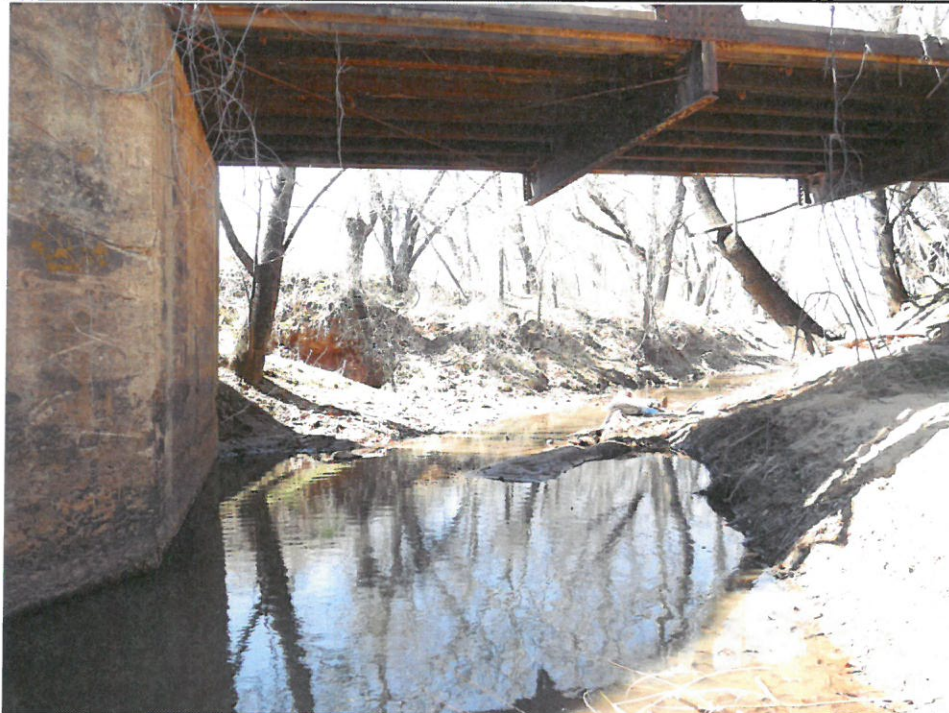
- **CX** – The stream is directed towards the south abutment at an approximate 30 degree angle (**photo 20**). This has caused a scour hole to develop along the breastwall of the south abutment. The most severe scour exists from the bridge centerline to the east edge of the abutment. This scour hole was measured to be 3 feet deeper than the thalweg measured upstream of the bridge. The scour hole has exposed the face of the footing. It could not be determined if the footing was undermined as the face of the footing is irregular and appears to have been cast against the soil. According to the Structural Inventory and Appraisal data the foundation is noted to be a spread footing. The soil is a sandy loam with no observed outcropping of bedrock. The stream flows from west to east at the bridge site.
- Sandbars exist in the channel downstream of the bridge.

Photograph 20 - Looking upstream at channel and bridge. Note: Stream impacts south abutment.

- Place riprap in front of the south abutment and along the south bank for 50 feet upstream of the bridge to protect the abutment foundation from the effects of further scour. Relocate the channel away from the south abutment by removing soil from the north bank and remove the tree growing in the channel at the west edge of the bridge.
- Place piles along the south edge of the south abutment backwall to allow the bearings to be jacked. The piles should be driven to the top of the abutment footing (or to refusal if the piles miss the foundation) and should be attached to the backwall. Once the bearings are level, the jacks can be encased in concrete to act as the permanent bridge seat.

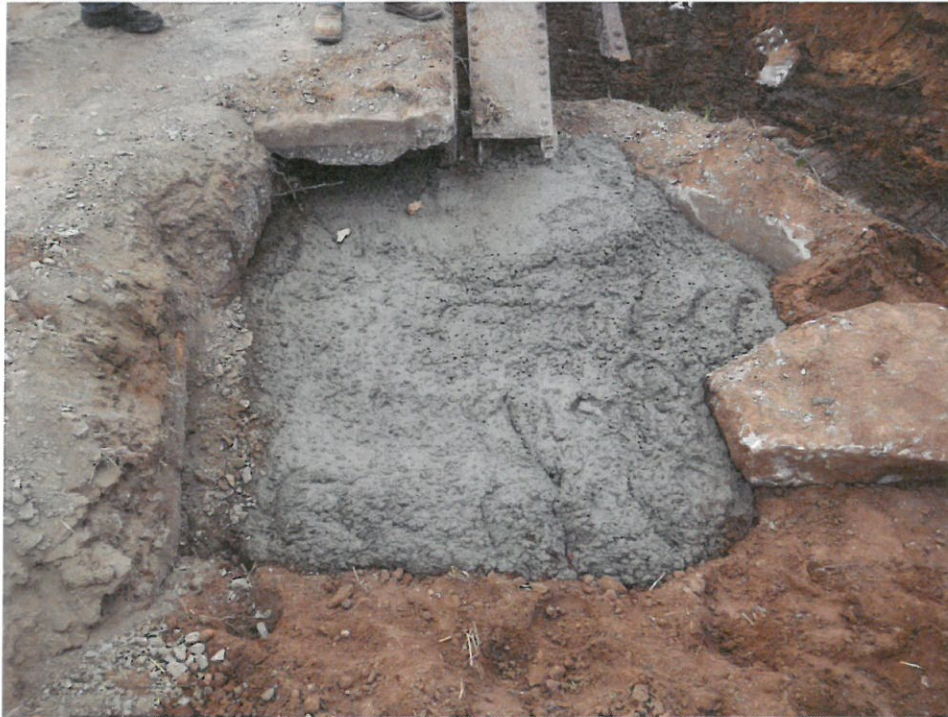
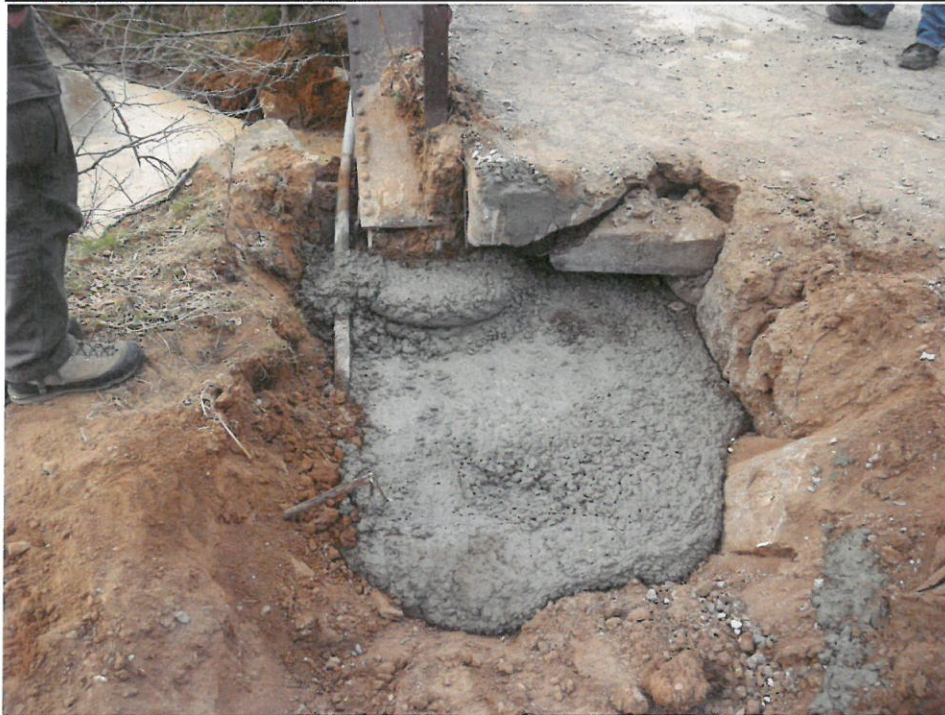
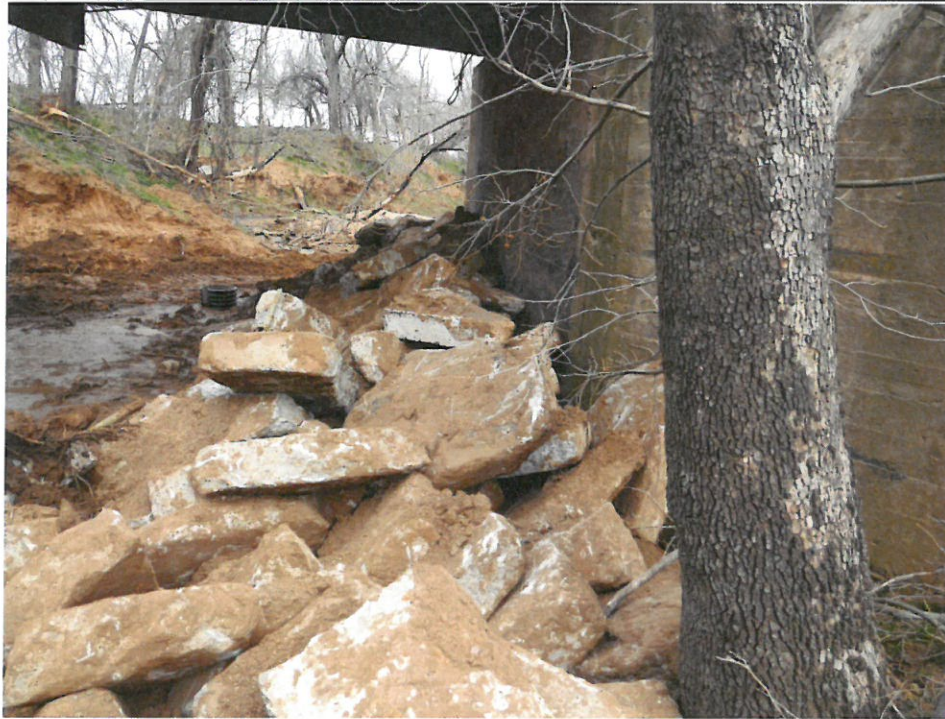
Photograph 21 - Looking north at bearing seat repair for the southeast bearing.

Photograph 22 - Looking north at bearing seat repair for the southwest bearing.

Photograph 23 - Looking east along south abutment at the riprap repair.

The CX finding was discussed with Mr. David Howard of Creek County District 2 on March 13, 2013 and a follow up letter (attached) was sent to the county on March 13, 2013. The CX items must be satisfactorily completed by June 9, 2013 (90 days past initial date informed). *Note: CX repairs were satisfactorily completed on April 1, 2013 and inspected by Dale Poorman and Ed Cinadr (photos 21, 22 and 23).*
